Property Inspection Report

4545 Strawberry Fields
Nashville, TN 37111

Prepared for: Elinore Rigby

Prepared by: Complete Home Inspections, Inc.
618 Split Rail Drive
Brentwood, TN 37027

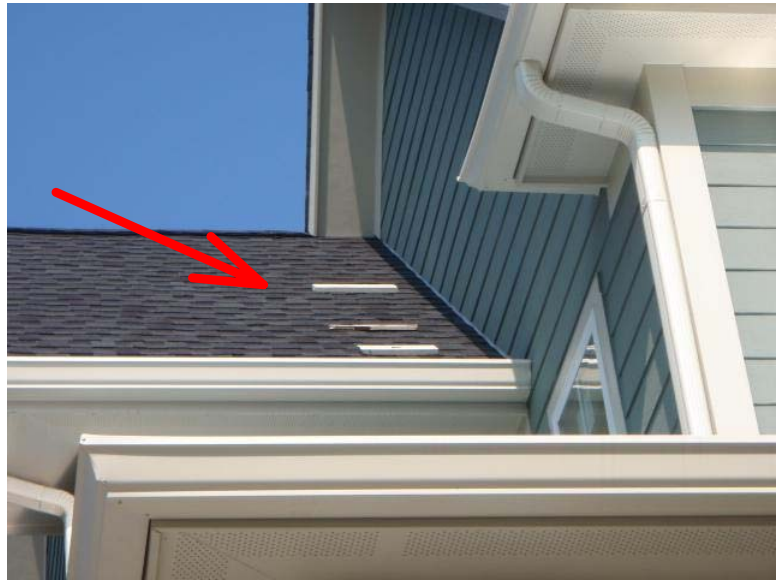
- 2. Roof Covering - Remove toe board from front of property and repair nail holes as per accepted trade practices.

Roof Covering - Improve/Minor Repair **Roof Covering** Remove toe board from front of property and repair nail holes as per accepted trade practices.

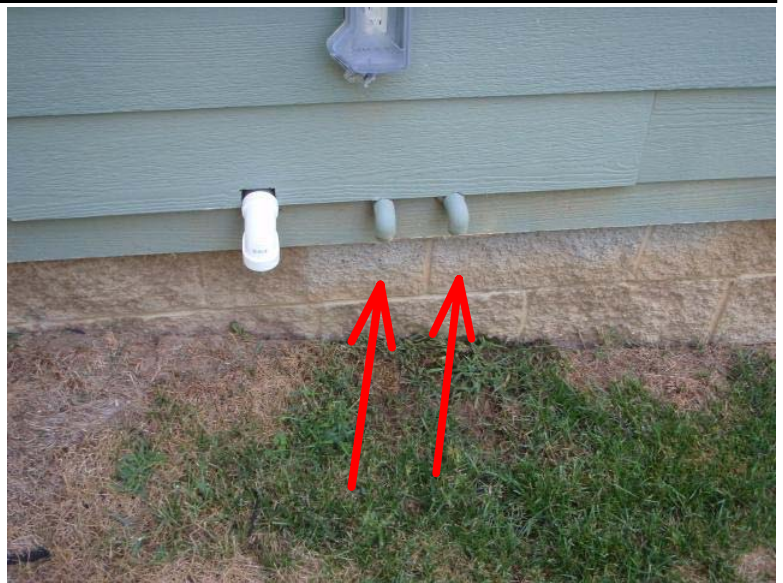
- 5. Condensate Removal - Install splash block at discharge lines to divert water away from foundation.

Temperature Differential: 15 ° F +/-
Exterior Condition - Functional
Energy Disconnect - Functional
Condensate Removal - Improve/Minor Repair Condensate Removal Install splash block at discharge lines to divert water away from foundation.
Visible Coil - Functional
Refrigerant Lines - Functional
System Operation - Functional

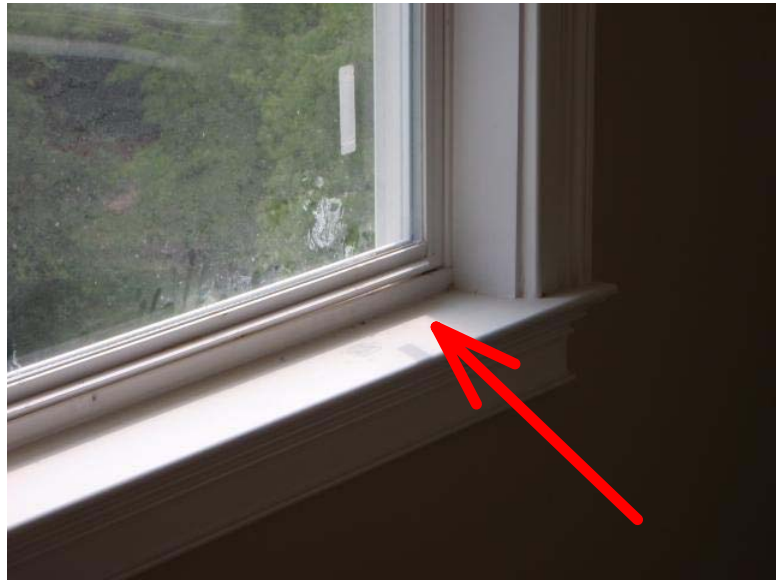
- 7. Windows - Window in front of stairwell does not close all the way. As a courtesy to the new home owner, have the builder clean the windows in this location.

Windows - Improve/Minor Repair **Windows** Window in front of stairwell does not close all the way. As a courtesy to the new home owner, have the builder clean the windows in this location.

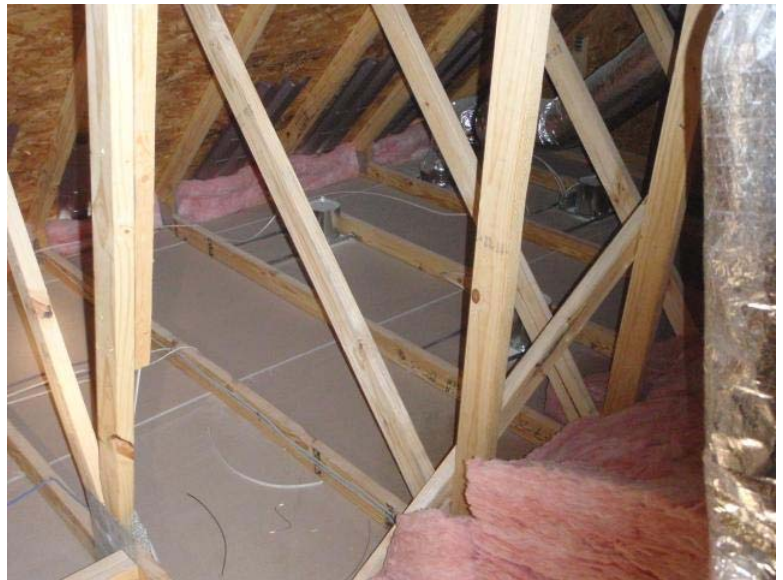
- 11. Insulation - Blown-in insulation has not been installed in the attic. Have builder address.

Insulation - Improve/Minor Repair **Insulation -** Blown-in insulation has not been installed in the attic. Have builder address.
